Lessons Learned from the Field

H.Q. Construction Office

Report

April 2005

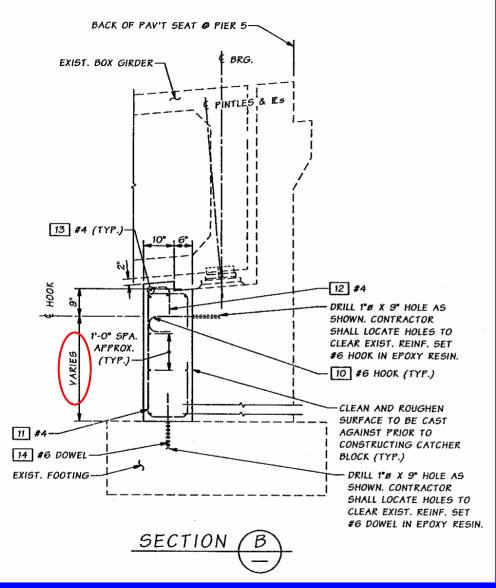
Seismic Retrofit Details and Specifications

"Varies" is not adequately descriptive

Recommendation

- Provide approx. dimensions
- Give estimated elevations
- Require Contractor to fieldverify

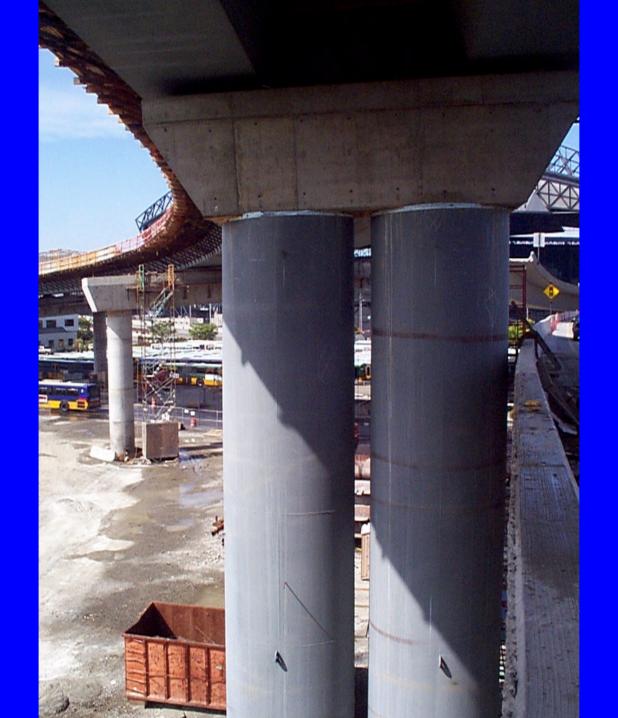
North Seattle Bridges - Seismic

Issues with seismic retrofit field measuring

- Make lump-sum payment
 - Not incidental to seismic work
 - Not a payment per each
- Specify that results are to be incorporated into shop drawings.
